Errata: CS4222 Rev. C(Reference CS4222 Data Sheet — DS236PP3 JAN '97)

CS4222 Revision C known problems. These problems also affect Rev. A plus the other known problems in that revision.

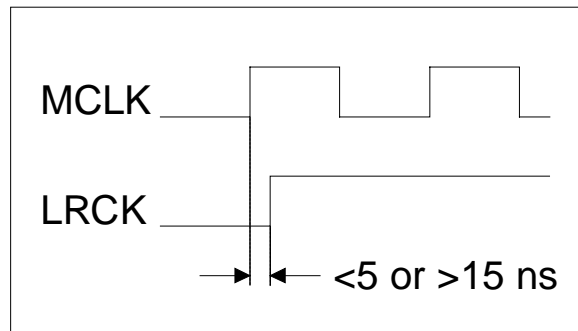
2) The following timing constraint was omitted from the data sheet: The rising edge of LRCK must be less than 5 ns or more than 15 ns after the rising edge of MCLK. This constraint can be met by synchronizing the LRCK with either the rising or falling edge of MCLK.
