## Errata: CS43L42 Rev. D

CS43L42 Low Voltage, Stereo DAC with Headphone Amp

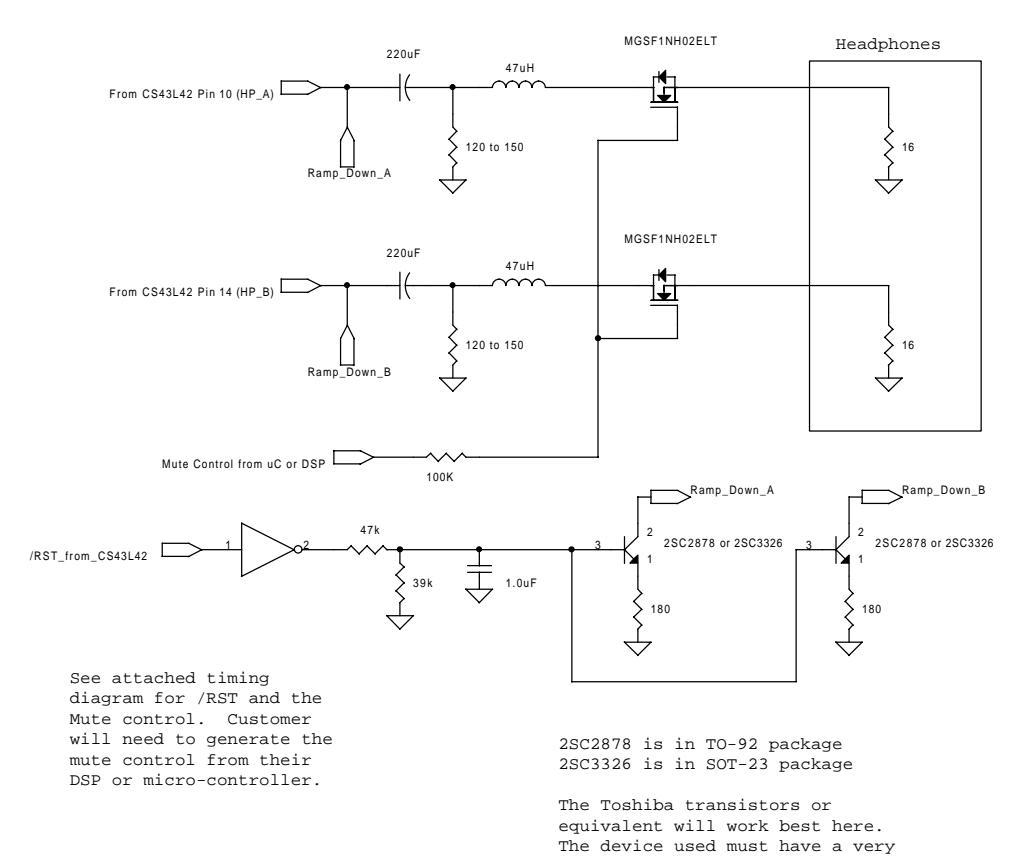
Figure 1. Pop Guard Fix

- The PopGuard<sup>©</sup> Transient Control does not function properly and will produce audible artifacts on the headphone and line outputs during power-up. A hardware fix is available for this issue. Please see Figures 1 and 2 for the headphone output fix. For the line outputs, please use the optional mute circuit shown in the CDB43L42 schematic to mask this problem.

- The PopGuard<sup>©</sup> Transient Control power-down ramp requires 5 seconds to prevent audible artifacts on the headphone outputs at the next power-up. A hardware fix is available for this issue, see Figures 1 and 2 for details. This fix will reduce the ramp down time to approximately 300 milliseconds.

The Motorola MOSFETs shown have been tested to work properly, however, an equivalent device may be used.

low Ron (3 ohms or less).
