Two Simple Solutions for *Tricky Problems*

How to Eliminate False Triggering

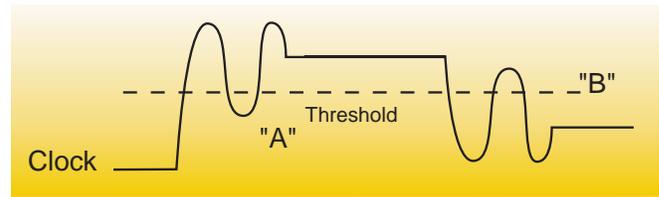
Systems with multiple un-correlated clocks are especially vulnerable, even when the clock edges are noise free. Ground bounce caused by one clock can occur during the transition of another clock, especially when this transition is slow, and can cause the apparently monotonic transition to be interpreted as multiple clock transitions inside the chip. In the past, FPGAs were slow enough to be forgiving, so that many high-frequency problems could be ignored. Now, double pulses separated by one or a few nanoseconds, as shown in Figure 1, can lead to double triggering and result in system failure.

Figure 1- Reflections Causing Clock Noise

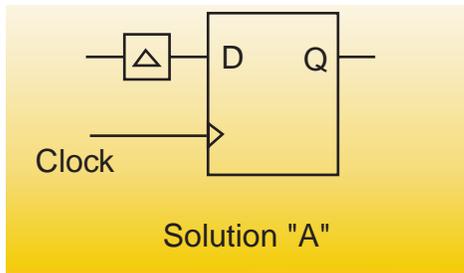
(A) Double clocking on the rising edge – this means that a reflection caused the internal clock signal to go Low-High-Low-High (L-H-L-H) instead of a simple Low-High (L-H) transition. The second L-H transition might clock the flip-flops again, if they are fast enough to respond to two clock edges that are only a few nanoseconds apart.

Figure 2 - Delaying the D-input

The simple solution is to give all affected flip-flops sufficient delay in front of the D-inputs, so they cannot change in the short time between the two rising clock edges, as shown in Figure 2. Use redundant LUTs or additional routing to slow the few flip-flops that are sensitive; typically they are the least-significant bits of a counter.

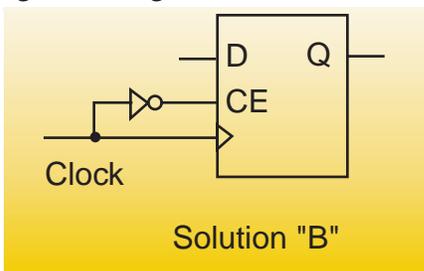
(B) Clocking on the wrong (falling) edge – this is always caused by a H-L-H-L sequence of clock transitions within a few nanoseconds. (No flip-flop can possibly be affected by the wrong edge. On the other hand, no flip-flop will ever ignore the edge it is supposed to trigger on.)

Figure 3 - Inverting the Clock

This false triggering which seems to occur on the wrong edge in the middle of the clock period cannot be cured by slowing down the flip-flop inputs. Instead, a slightly delayed and inverted version of the incoming clock signal must be used as Clock Enable to the flip-flops, as shown in Figure 3. CE will be active High before and during the legitimate rising clock edge, but will be inactive (Low) before and during the unintended clock glitch, caused by a reflection of the falling clock edge.
