Introduction

This document describes the errata information on the FP-MCU AG1F1 and AG1F4 devices. Details include known issues, trigger conditions, affected devices, and available workaround. This errata sheet should be used to compare to the datasheets for these devices to fully describe the device functionalities.

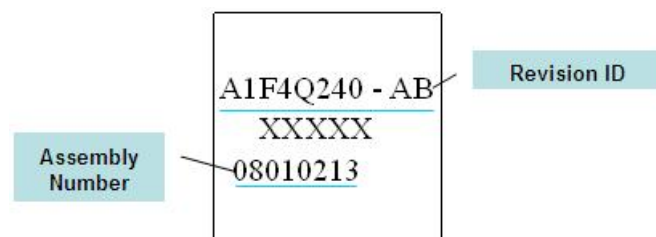
Figure 1 FP-MCU Device Top-side Marking

These errata apply to the FP-MCU family devices. The device revision is identified by the Revision ID on the top-side marking. **Figure 1** shows a FP-MCU device's top-side marking. The other devices are marked similarly.
